“TROUBLE UNDER FOOT” RESURFACING HISTORIC FLOOR SYSTEMS

Alicia E. DIAZ DE LEON, AIA¹, Michael J. DRERUP, P.E.²

Proceedings of the International Conference on Forensic Engineering, Mumbai, India, December 6-9, 2007

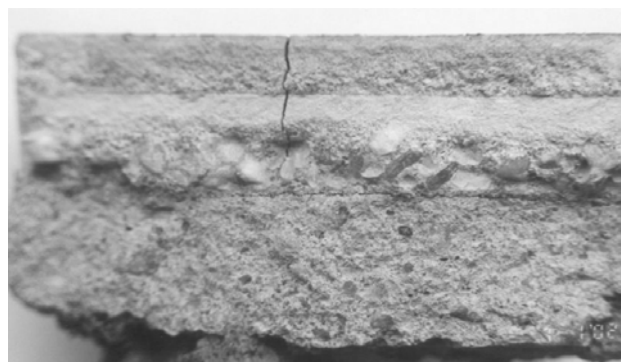
Figure 4 - Cracking and curling of leveling mortar (Beasley)

Drying shrinkage of portland cement matrices is an issue that affects all cementitious concrete materials. Several inherent characteristics of leveling mortars make them especially vulnerable to drying shrinkage; these include the typical thinness of installation, lack of wet curing (wet curing is not required by the manufacturers of the tested products), low aggregate content, and lack of fiber or metal reinforcement. The leveling mortars we studied employ a variety of mechanisms to control drying shrinkage, principally including a strong substrate bond and the inclusion of gypsum or a related sulfate compound in the mix. Both of these mechanisms are potentially problematic; gypsum can cause continued expansive formation of ettringite in the presence of moisture, and the substrate bond is highly dependent upon proper execution of all aspects of the installation. Previous studies also showed that aggregate segregation and associated differential shrinkage are significant factors that adversely affect leveling mortar performance. In many cases petrography revealed that aggregate particles had settled to the bottom of the leveling mortar layer, leading to cracking, differential shrinkage across the thickness of the mortar, and upward curling. Figure 3 schematically illustrates the curling phenomenon. Figure 4 shows the effects of this phenomenon at one of the facilities we studied.

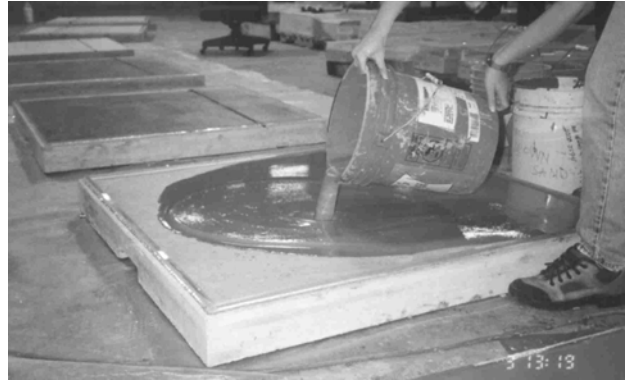
Figure 6 - Placement of leveling mortar

After mixing, the material was poured onto the prepared substrate and lightly troweled to spread it uniformly. A small amount of the freshly mixed material was drawn off during the placement to prepare test bars for drying shrinkage evaluation. Placement is shown in Figure 6.
